Maine Statewide Bacteria TMDL:2013 Freshwater Addendum

Appendix B: Goosefare Brook Bacteria Sampling Project Reports

Report #: *DEPLW-1254*

*2012 Data Report
Goosefare Brook - Saco, Maine*

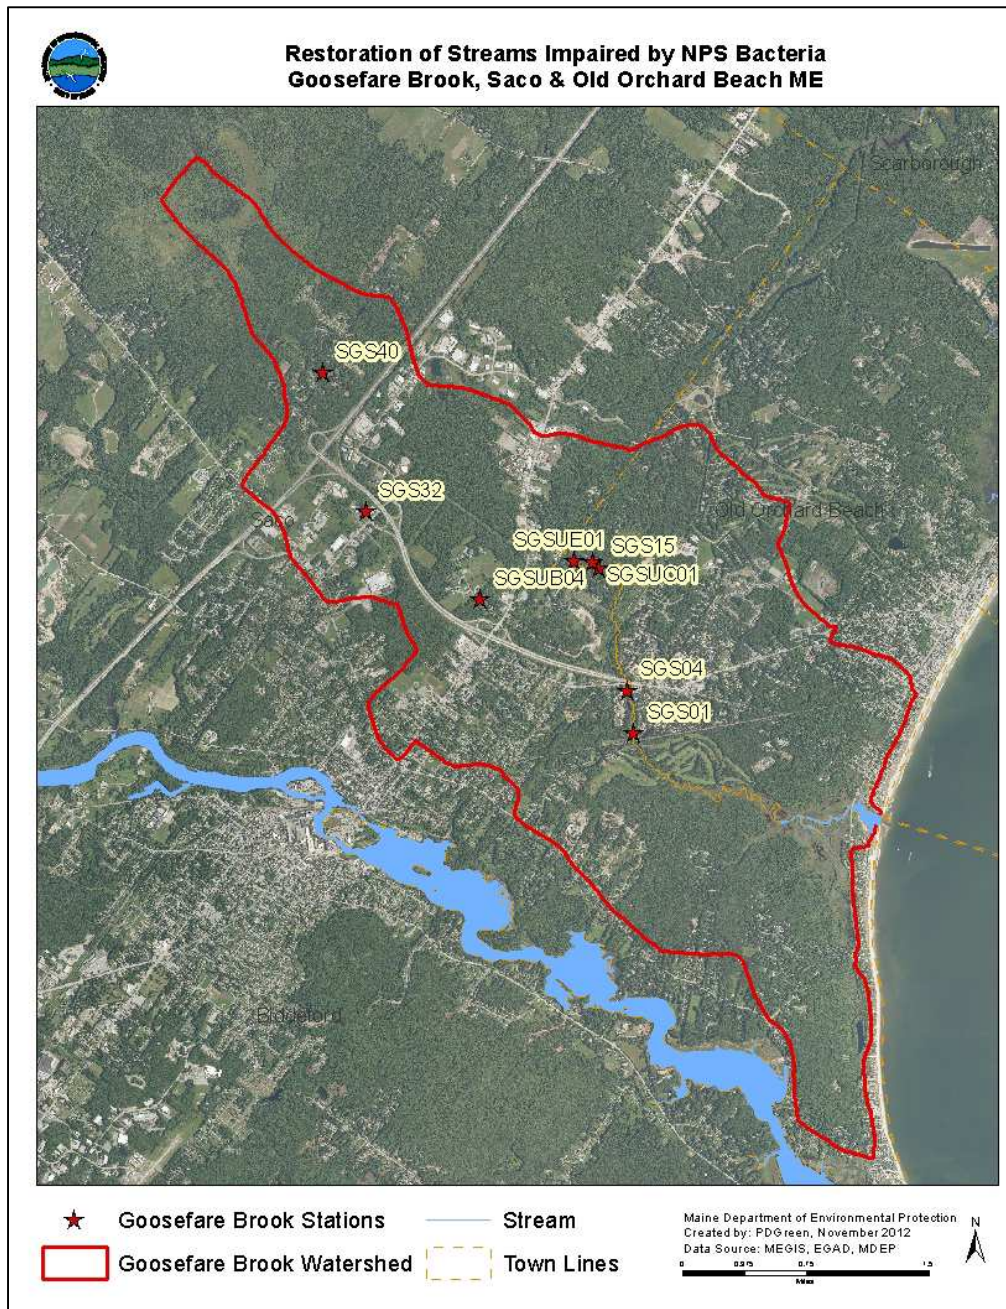
Figure 1. Goosefare Brook flows through a mixed landscape.

Goosefare Brook is a Class B stream situated in the city of Saco with a small segment in the town of Old Orchard Beach in York County, Maine (Figure 1). The lower main stem flows for 1.18 miles before it empties into Saco Bay. The Goosefare Brook watershed drains approximately 9.46 square miles of the greater Piscataqua-Presumpscot-Saco watershed. In addition to the main stem, three tributaries are included in this discussion.
